RAIDER OUTBOARDS SERVICE BULLETIN RO2019-002 (July 23, 2019) formally NR. 002

- 1. Spark Plug arcing to Cylinder Head.
 - a. Engine Model: Raider 40 HP and 50 HP
 - b. Item: After submersion and dewatering, some Operators experienced difficulties getting the motor to start/fire. During submersion performance testing it was noted that approximately 15% of the time motors were difficult to start or ran erratically. The cause was determined to be from water intrusion due to insufficient dielectric grease application inside the plug wire boots, which allowed for the ignition spark to arch directly from the plug to cylinder head. After corrective maintenance actions were implemented zero failures were noted.

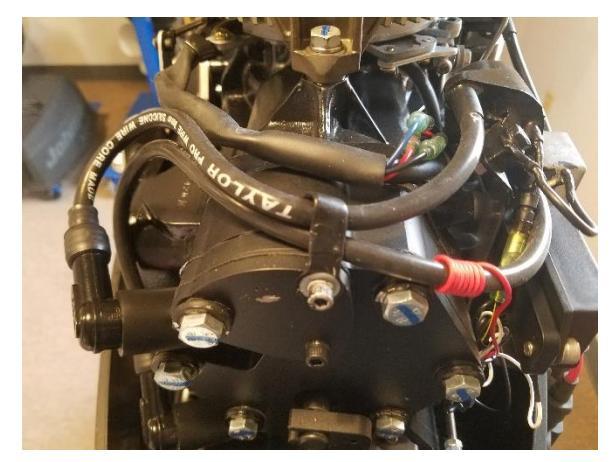
Fig (1) 40 HP ignition coil and spark plug wires.

- 1) Remove Engine cowling.
 - 2) Visually Inspect the ignition coil and plug wires for, corrosion, chaffing, cracked wire insulation. (see fig. 1 and 2)

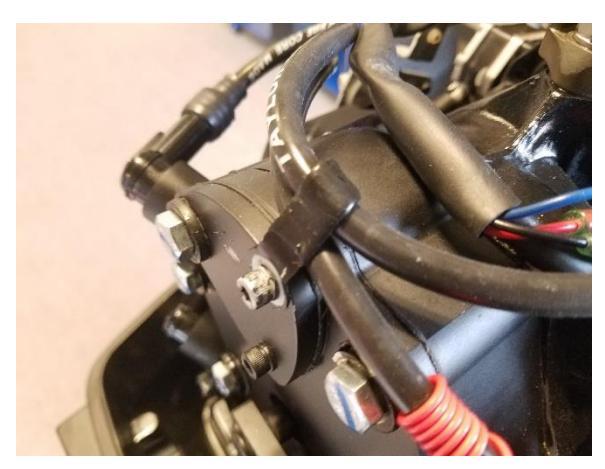
Fig (3) 40 HP plug wire retainer.

- 3) Visually inspect plug wire retainers/clamp for wear and tear, replace if required. (see fig 3)
 - 4) Visually Inspect the spark plug boots chaffing and cracks, ensure that the 2" boots are installed (see service bulletin NR. 001 dated 25 April 2019). (see fig 4 and 5)

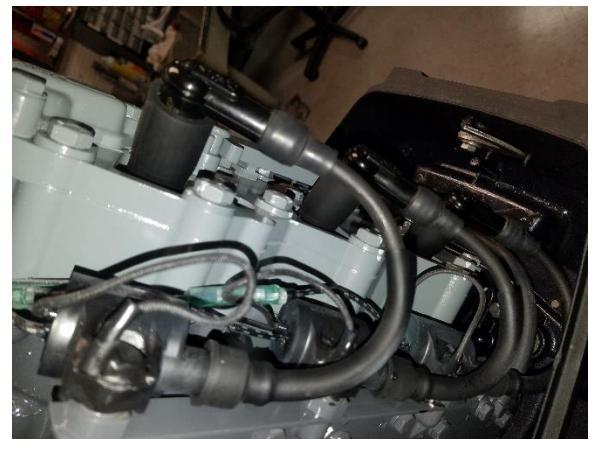
Fig (5) 50 HP Ignition Coil installed with 2" Boots.

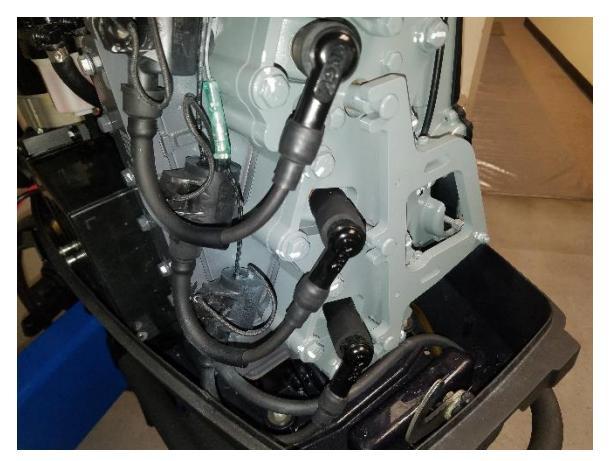
Fig (2) 40 HP ignition coil and spark plug wires.

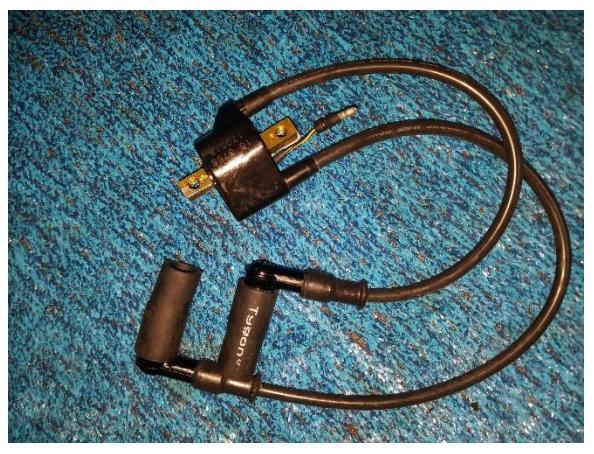
Fig (4) 40 HP Ignition Coil with 2" Boots.

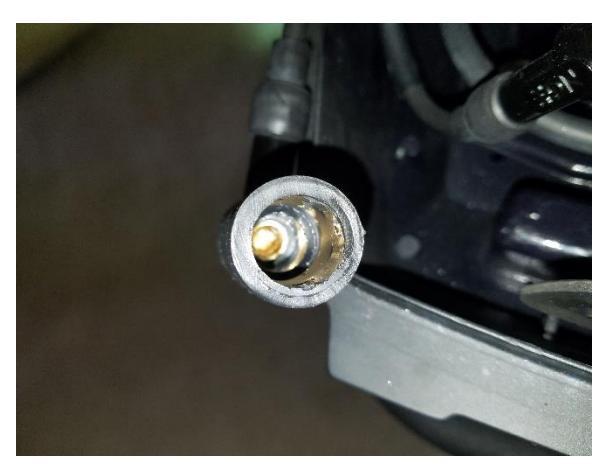
Fig (6) Interior Boot Inspection, no moisture, no debris.

- 5) Starting from the upper cylinder and working down the cylinder head remove one plug wire at time and perform the following:
 - a) Visually inspect the interior of the plug boot, look for corrosion, chaffing, cracks or dry rot. (see fig 6)

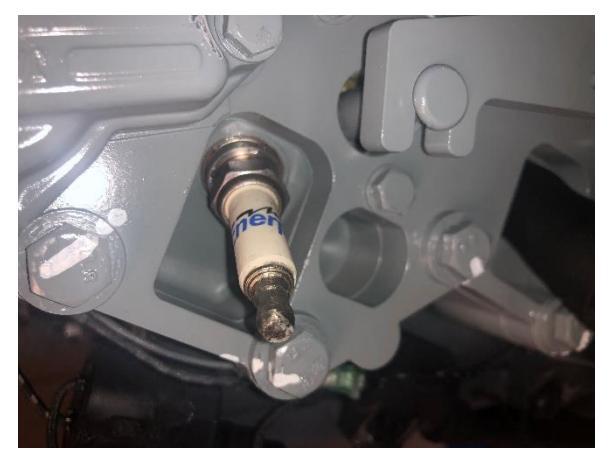
Fig (7) Plug ceramic inspection.

- b) With low-pressure air remove any moisture that may have collected within the interior of the plug boot.
 - c) Visually inspect the plug ceramic for cracks. (see fig 7)

- d) Visually inspect the plug end for corrosion. (see fig 7)
 - e) Ensure the plug is fully seated in cylinder head.

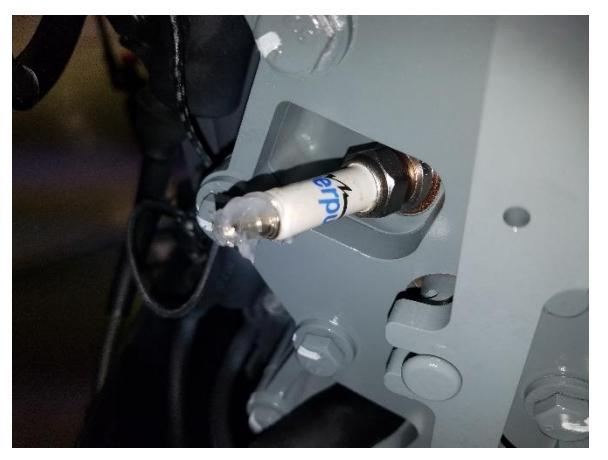
Fig (9) Apply grease to plug head.

- f) With a clean shop towel and low-pressure air remove any debris or moisture from around the plug base. (see fig 8)
- g) Place an ample amount of dielectric grease on the end of the plug. (see fig 9)

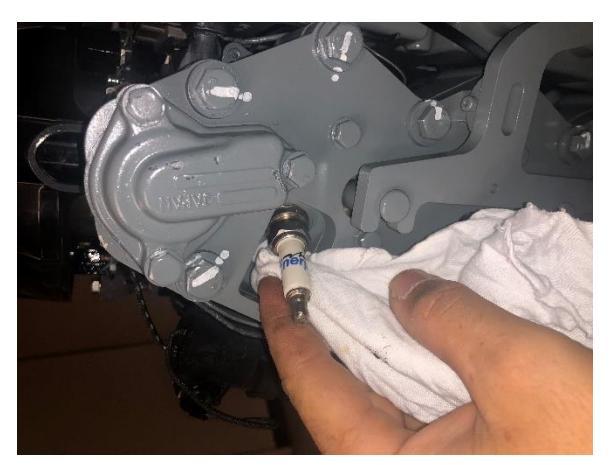
Fig (8) Clean any moisture or debris from around plug.

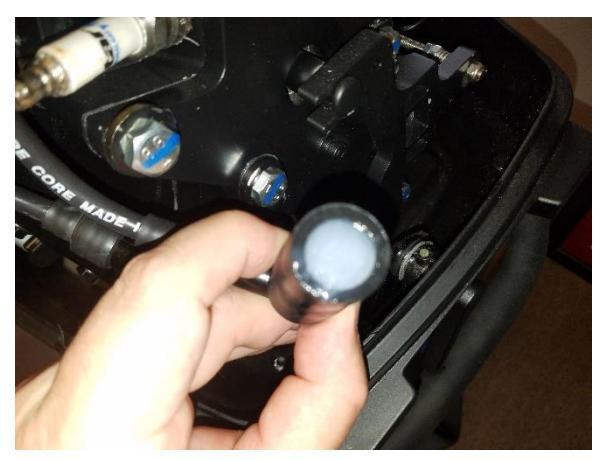
Fig (10) Fill boot with grease.

- h) Fill the plug boot with dielectric grease. (see fig 10)
- i) Connect the spark plug wire boot over the end of the spark plug. (see fig 11 and 12)
- j) With a clean shop towel remove any excess dielectric grease from around the boot and cylinder head. (see fig 13)

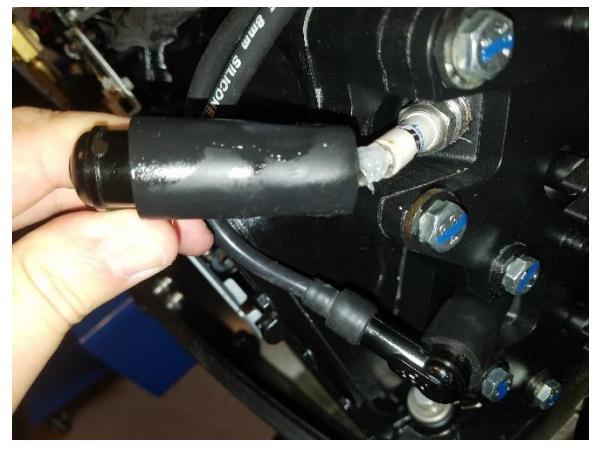
Fig (11) Reconnect plug wire to plug.

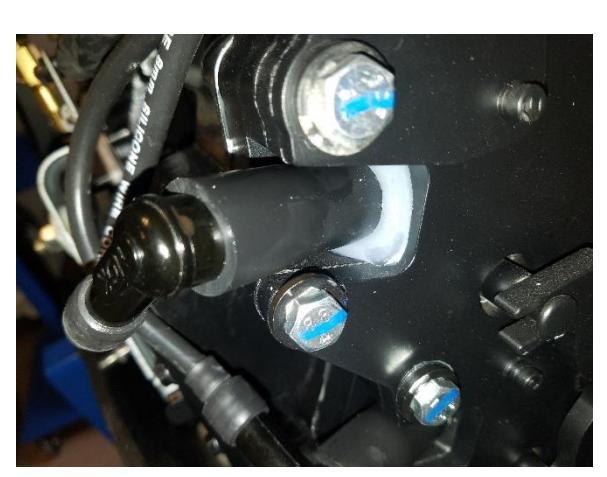
Fig (12) Plug wire fully seated.

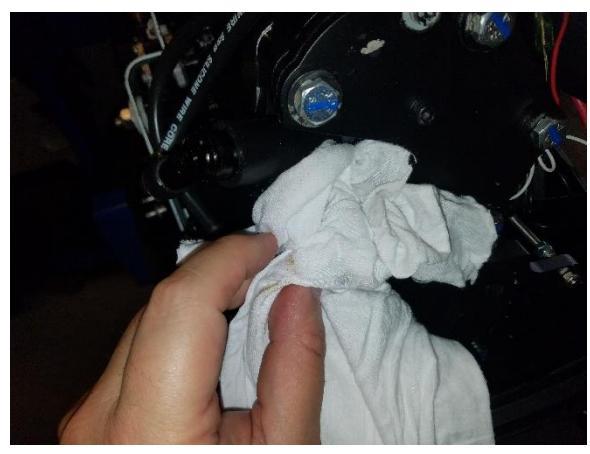
Fig (13) Remove excess grease.

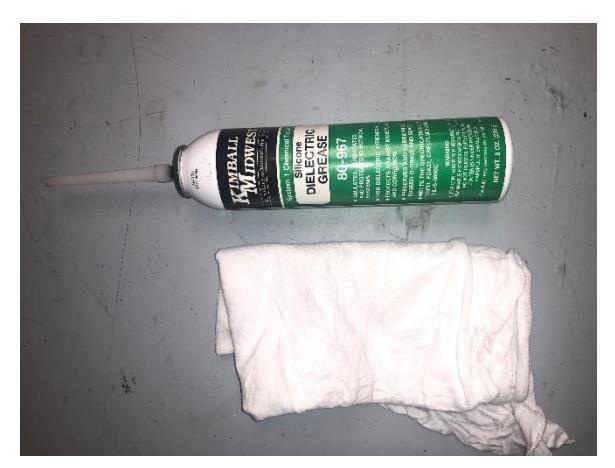
Fig (15) Meets MIL-S-8660C, SAE-AS8660

- 7) Replace the Engine Cowling.
- 8) Place motor into service.
- d. Materials. Dielectric grease MIL-S-8660C, MILITARY SPECIFICATION: SILICONE COMPOUND, NATO CODE NUMBER S-736 (22 SEP 1983) [S/S BY SAE-AS8660]. This specification covers one type of a non-melting, heat stable silicone compound for use in high tension electrical connections, ignition systems and electronics equipment; for application to unpainted mating threaded or non-threaded surfaces, and as a lubricant for compounds fabricated from rubber. This compound is effective in the temperature range from -54°C (-65°F) to +204°C, (+400°F) for extended periods and to 260°C (500°F) for short periods. (see fig 15)

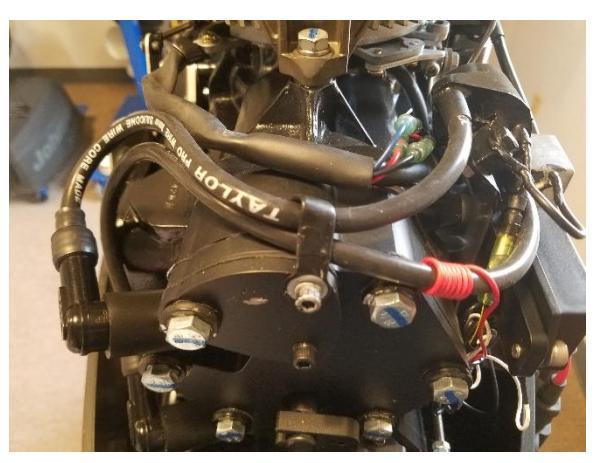
Fig (14) Route plug wires through retainer.

- k) Repeat this process for each remaining plug wire boot. When all wires are complete proceed to the next step.
- 6) Ensure that each plug wire is properly secured in its retainer clamp and not rubbing on any moving motor part or surface. (see fig 14)

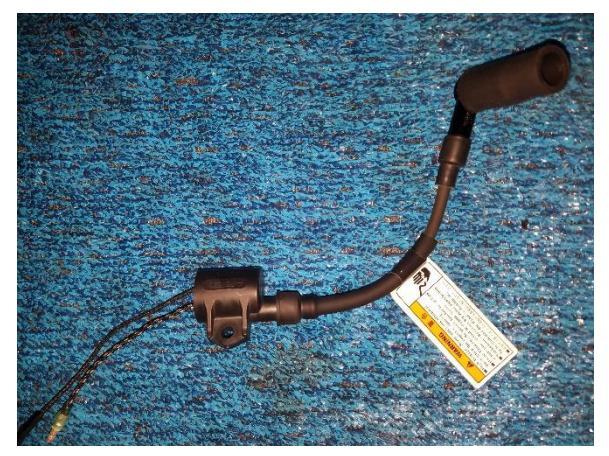
Fig (16) Individual 50 HP Ignition Coil, wire, with 2"Boot.
